City of San Diego  
FY15 Facility Condition Assessment Report for:  
**Facility # 000001 Office. City Administration Building. CAB. Downtown**

**FACILITY EXECUTIVE SUMMARY**

**Facility # 000001 Office. City Administration Building. CAB. Downtown**

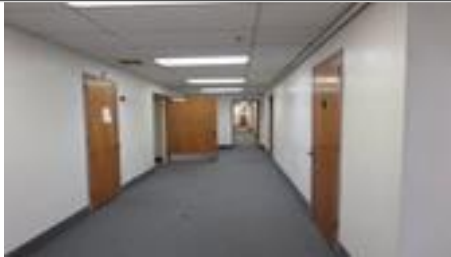
DEFICIENCY REPORT – Building Only							
Year	Priority	Subsystem	Correction	Photo	Location	Funding Type	Cost
2015	Recommended	Interior Doors	Replace

1965 System	Capital	\$5,054,665
2015	Recommended	Wall Finishes	Replace

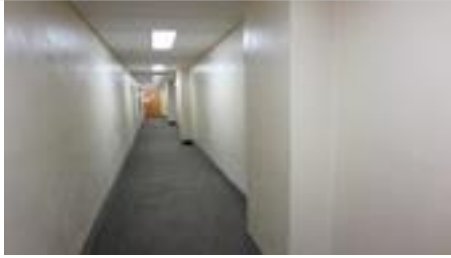
1965 System	Capital	\$1,177,304
2015	Necessary	Exterior Doors	Replace

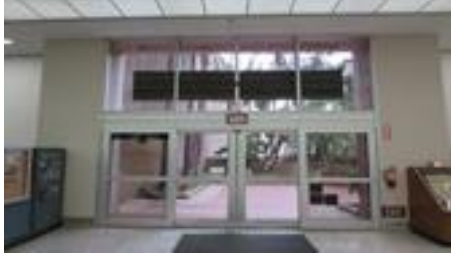
1965 System	Capital	\$1,116,288

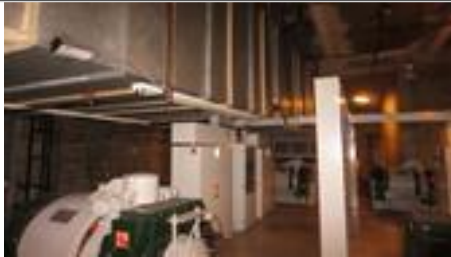
DEFICIENCY REPORT – Building Only							
Year	Priority	Subsystem	Correction	Photo	Location	Funding Type	Cost
2015	Critical	Other Electrical or Generator	Replace

1965 System	Capital	\$946,838
2015	Necessary	Distribution Systems	Replace

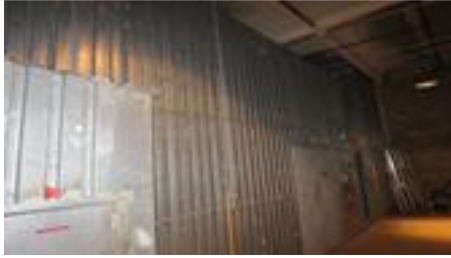
Floor: 10 Room: HVAC Room ID: Type: Air Handling Units	Capital	\$860,564
2015	Recommended	Sanitary Waste	Replace

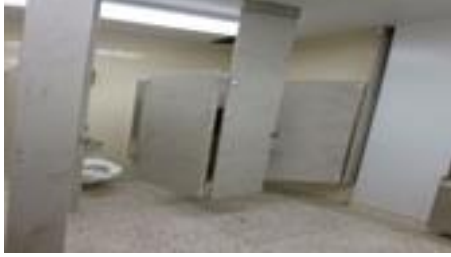
1965 System	Capital	\$722,304

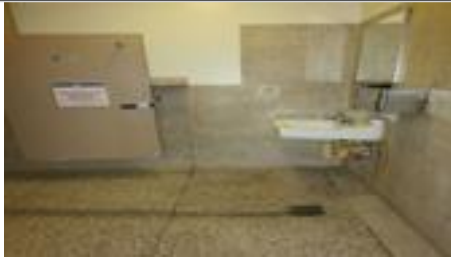
DEFICIENCY REPORT – Building Only							
Year	Priority	Subsystem	Correction	Photo	Location	Funding Type	Cost
2015	Potentially Critical	Domestic Water Distribution	Replace

1965 System	Capital	\$475,333
2015	Critical	Roof Coverings	Replace

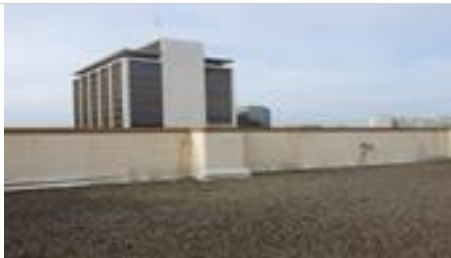
1965 System	Capital	\$444,488
2015	Recommended	Stair Finishes	Replace

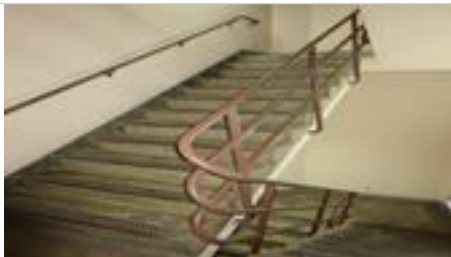
1965 System	Capital	\$359,252

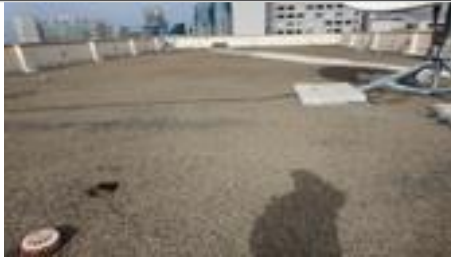
DEFICIENCY REPORT – Building Only							
Year	Priority	Subsystem	Correction	Photo	Location	Funding Type	Cost
2015	Critical	Roof Coverings	Replace

Floor: Roof 1 Room: Roof 1 ID: Type: Built up Roof	Capital	\$151,413
2015	Recommended	Wall Finishes	Remove and Replace

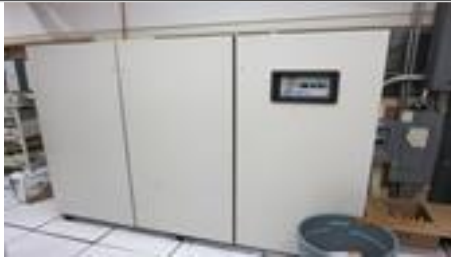
DEFICIENCY REPORT – Building Only							
Year	Priority	Subsystem	Correction	Photo	Location	Funding Type	Cost
2015	Necessary	Distribution Systems	Replace

Floor: B1 Room: Main IT Room ID: Type: Air Handling Units	Capital	\$48,803
2015	Necessary	Distribution Systems	Replace

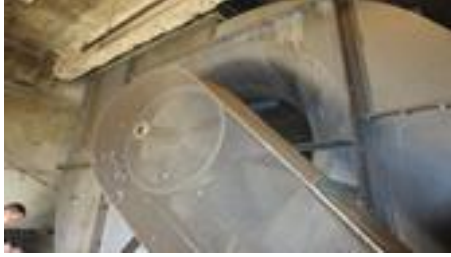
Floor: B1 Room: Main IT Room ID: Type: Air Handling Units	Capital	\$48,803
2015	Necessary	Distribution Systems	Replace

Floor: Roof 1 Room: HVAC Room ID: 369795 Type: Exhaust Fans	Capital	\$33,392

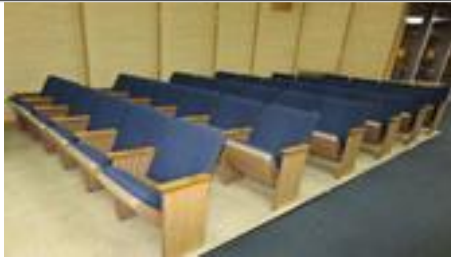
DEFICIENCY REPORT – Building Only							
Year	Priority	Subsystem	Correction	Photo	Location	Funding Type	Cost
2015	Recommended	Fixed Furnishings	Renew Finishes

Floor: 10 Room: Council Chambers	Maintenance	\$21,671
2015	Potentially Critical	Domestic Water Distribution	Replace

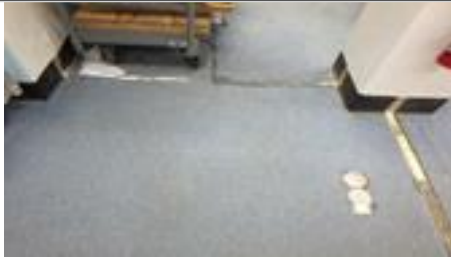
DEFICIENCY REPORT – Building Only							
Year	Priority	Subsystem	Correction	Photo	Location	Funding Type	Cost
2015	Recommended	Floor Finishes	Remove and Replace

Floor: B1 Room: Mail Room and Storage	Maintenance	\$16,065
2015	Necessary	Distribution Systems	Replace

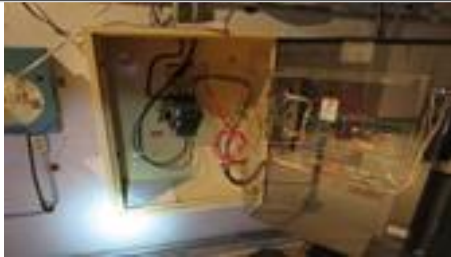
DEFICIENCY REPORT – Building Only							
Year	Priority	Subsystem	Correction	Photo	Location	Funding Type	Cost
2016	Potentially Critical	Electrical Service Distribution	Replace

Floor: 10 Room: HVAC Room ID: K30867 Type: Electrical Panel	Capital	\$9,346
2017	Critical	Communications and Security	Replace

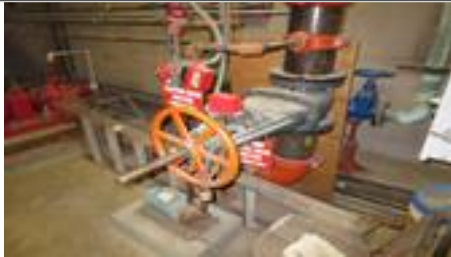
DEFICIENCY REPORT – Building Only							
Year	Priority	Subsystem	Correction	Photo	Location	Funding Type	Cost
2019	Critical	Sprinklers	Replace

Floor: B1 Room: Fire Pump Room ID: Type: Fire Suppression Valve	Capital	\$7,922
2020	Necessary	Other Conveying Systems	Replace

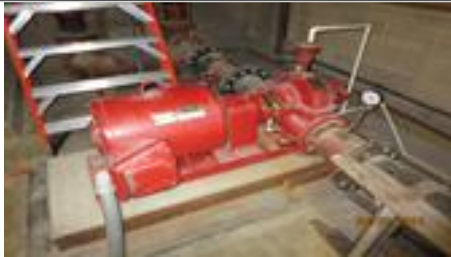
DEFICIENCY REPORT – Building Only							
Year	Priority	Subsystem	Correction	Photo	Location	Funding Type	Cost
2024	Critical	Sprinklers	Replace

Floor: B1 Room: Fire Pump Room ID: 99-F483DF6 Type: Fire Suppression Pumps	Capital	\$27,284
2024	Potentially Critical	Terminal and Package Units	Replace

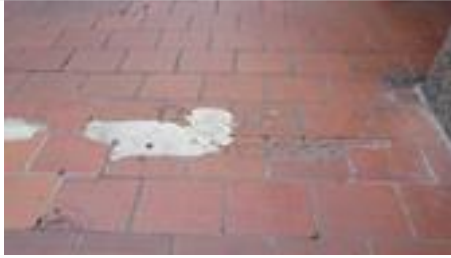
1965 System	Capital	\$101,819
2015	Recommended	Pedestrian Paving	Remove and Replace

Floor: 1 Room: Exterior	Maintenance	\$3,561
2015	Recommended	Landscaping	Remove and Replace
